**COMPARATIVE PERFORMANCE OF STRUCTURAL LAYERS IN
PAVEMENT SYSTEMS**

**VOLUME I. DESIGN, CONSTRUCTION, AND BEHAVIOR
UNDER TRAFFIC OF PAVEMENT TEST SECTIONS**

ARMY ENGINEER WATERWAYS EXPERIMENT STATION

JUNE 1974

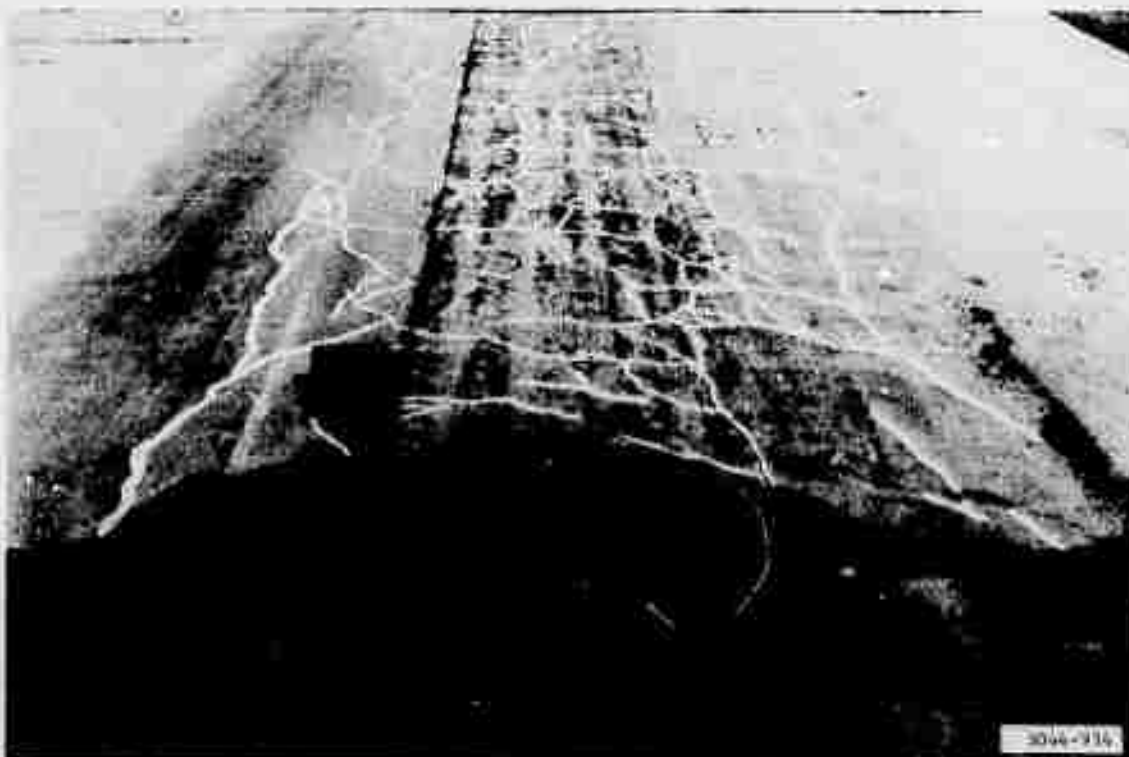
Item 1. The pavement structure in item 1 consisted of 7 in. of fibrous-reinforced concrete over a 20-in.-thick MESL base course. At 3000 coverages of the 200-kip load, the entire item was severely cracked and was considered to have reached the complete failure condition. Under the 240-kip load in lane 2, cracking became severe over the entire item at 1010 coverages, and the item was considered to have reached the complete failure condition.

Figure A4. Item 1, lane 1, rigid pavement test section, after 3000 coverages by 200-kip twin-tandem assembly

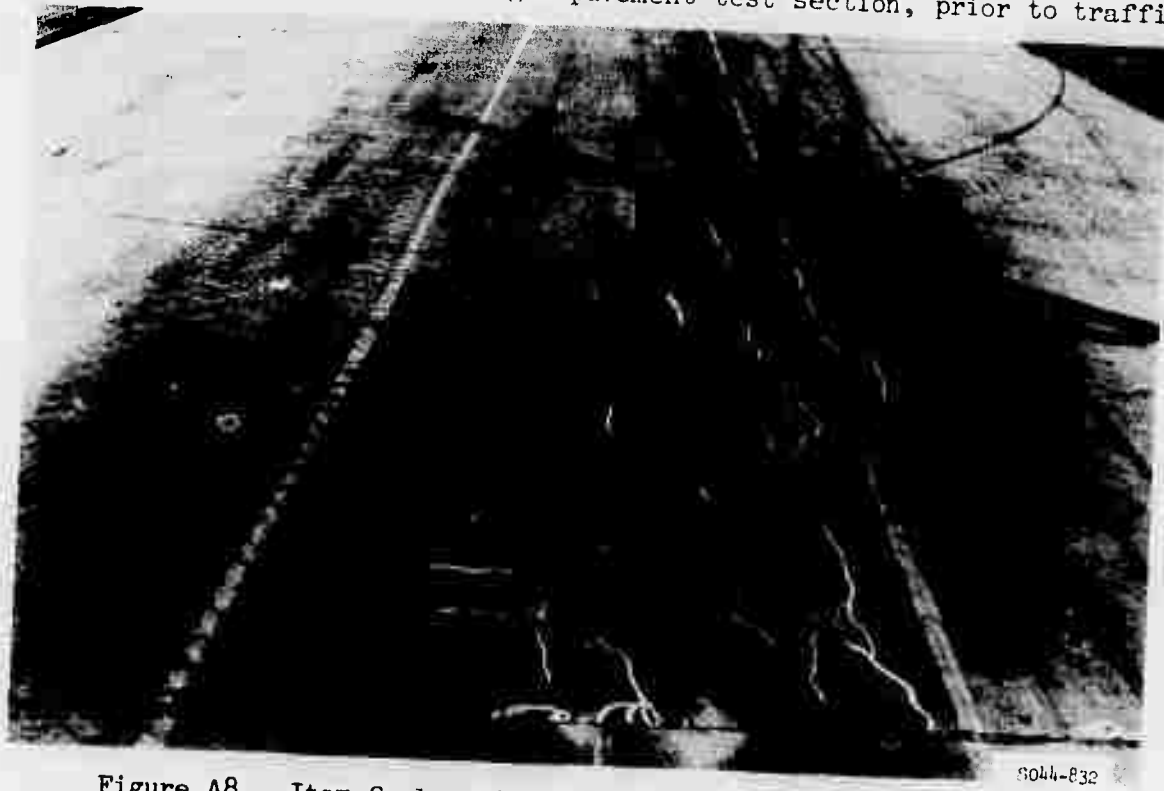
Figure A8. Item 2, lane 1, rigid pavement test section, after 200 coverages by 200-kip twin-tandem assembly

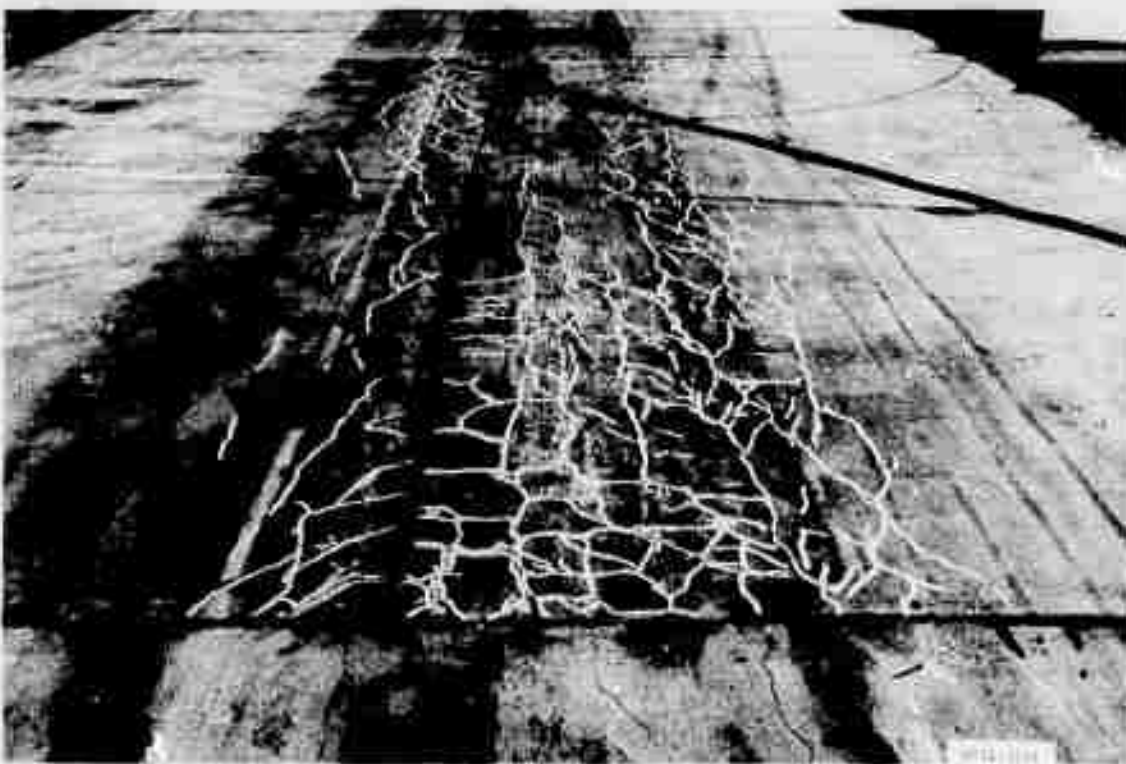
Item 2. Item 2 consisted of 4 in. of fibrous-reinforced concrete on a 17-in.-thick base course composed of clay gravel stabilized with 6 percent portland cement. The item was considered completely failed at

Figure A10. Item 2, lane 1, rigid pavement test section, after 1770 coverages by 200-kip twin-tandem assembly

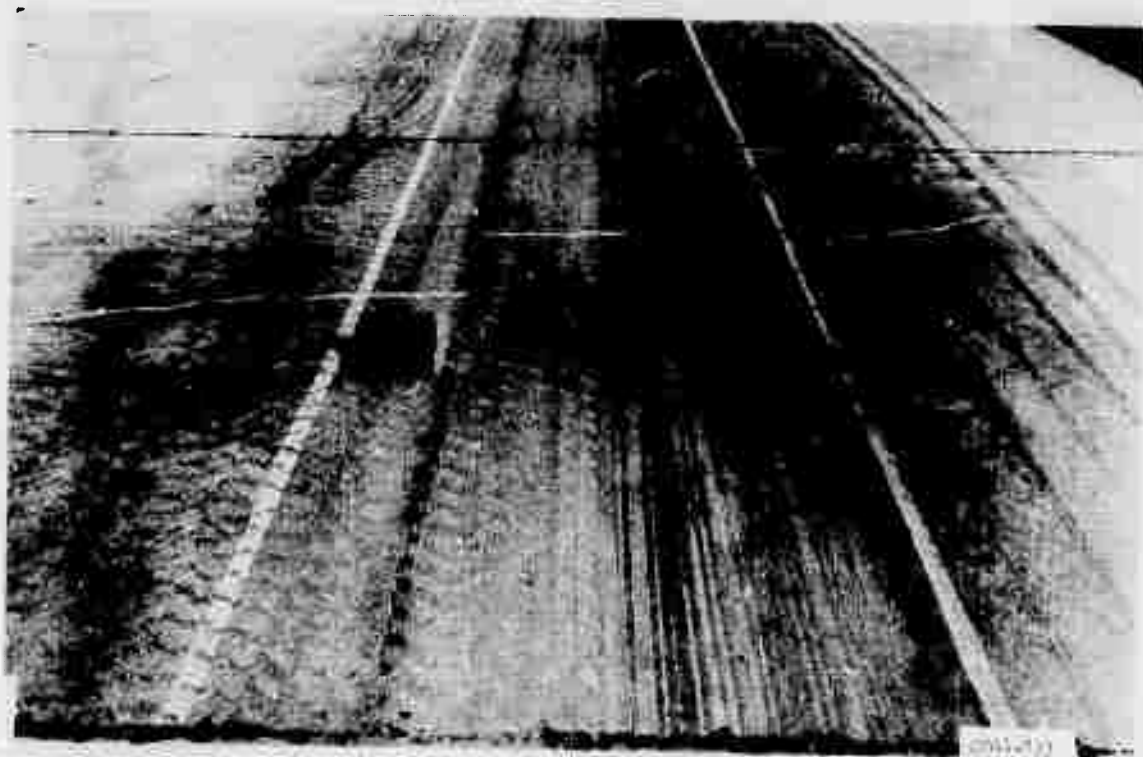
Figure A13. Item 3, lane 1, rigid pavement test section, after 200 coverages by 200-kip twin-tandem assembly

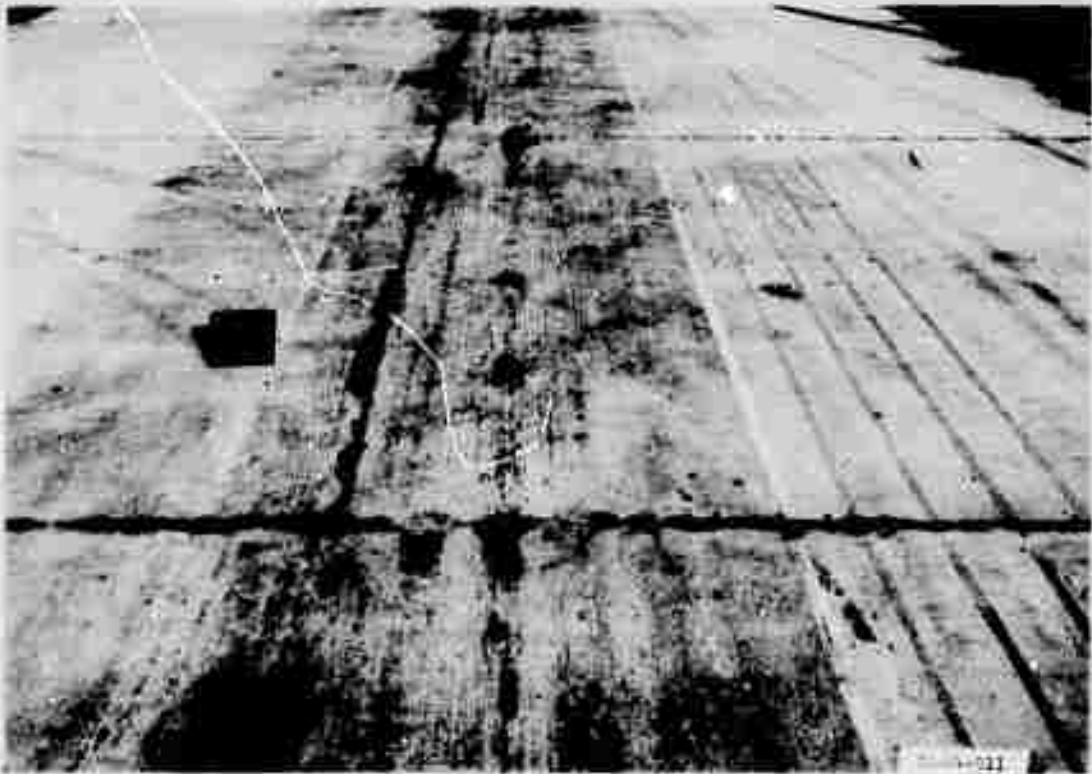
Figure A18. Item 4, lane 1, rigid pavement test section, after 1770 coverages by 200-kip twin-tandem assembly

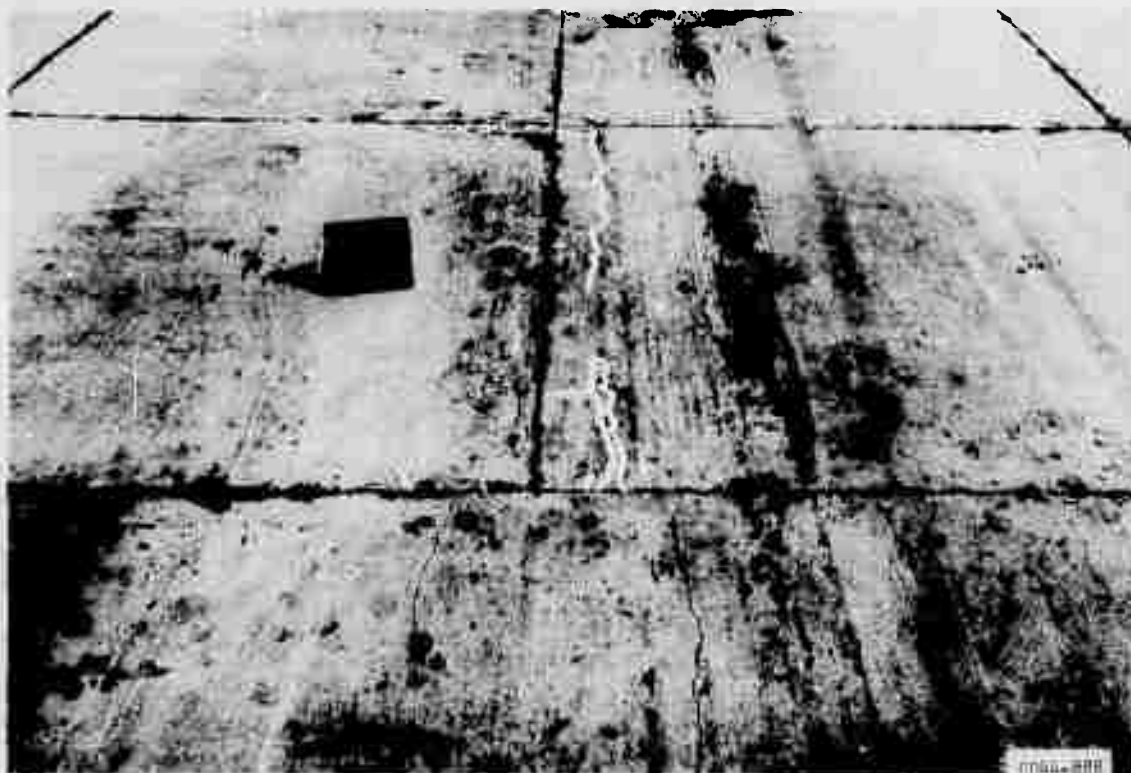
Figure A22. Subitem 5a, lane 1, rigid pavement test section, after 1770 coverages by 200-kip twin-tandem assembly

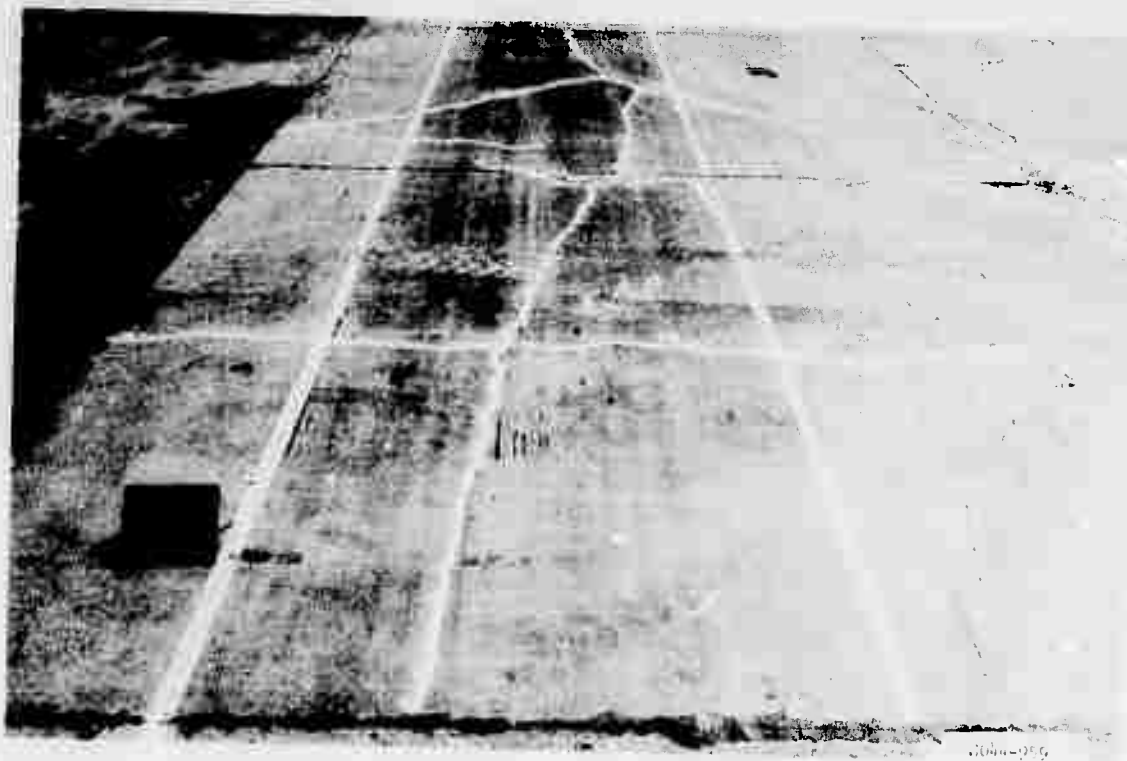
Figure A45. Item 4, lane 2, rigid pavement test section, after 200 coverages by 240-kip twin-tandem assembly

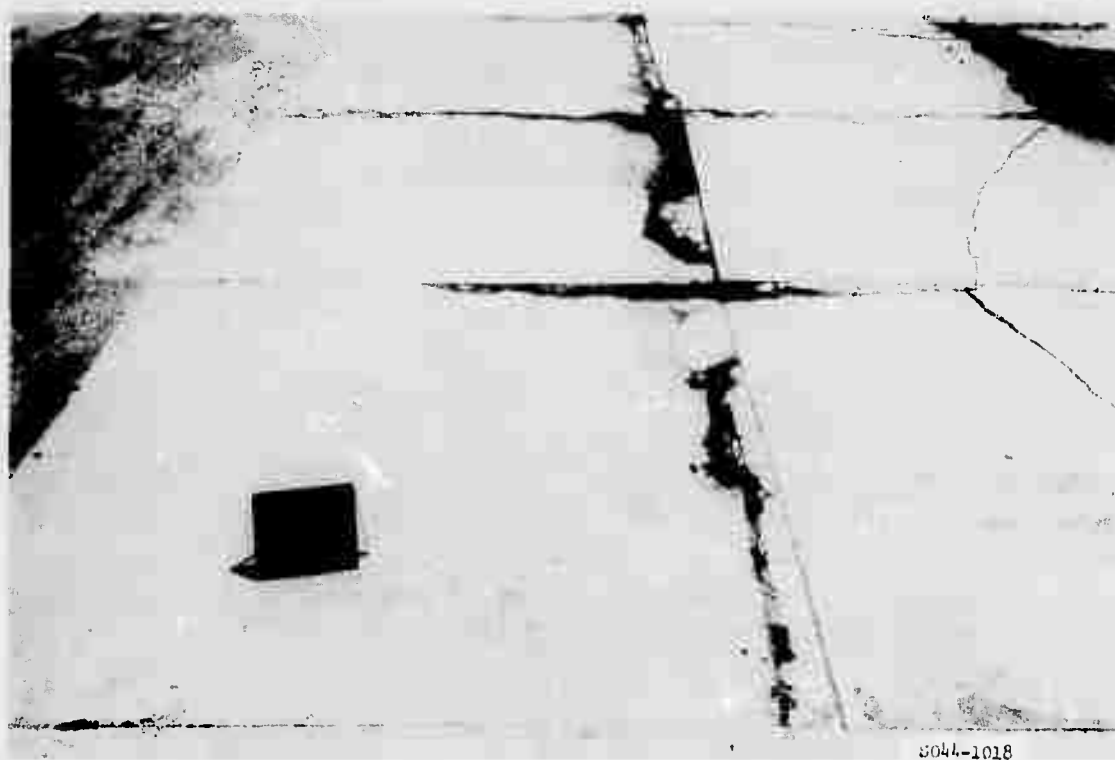
Figure A49. Subitem 5a, lane 2, rigid pavement test section, after 950 coverages by 240-kip twin-tandem assembly

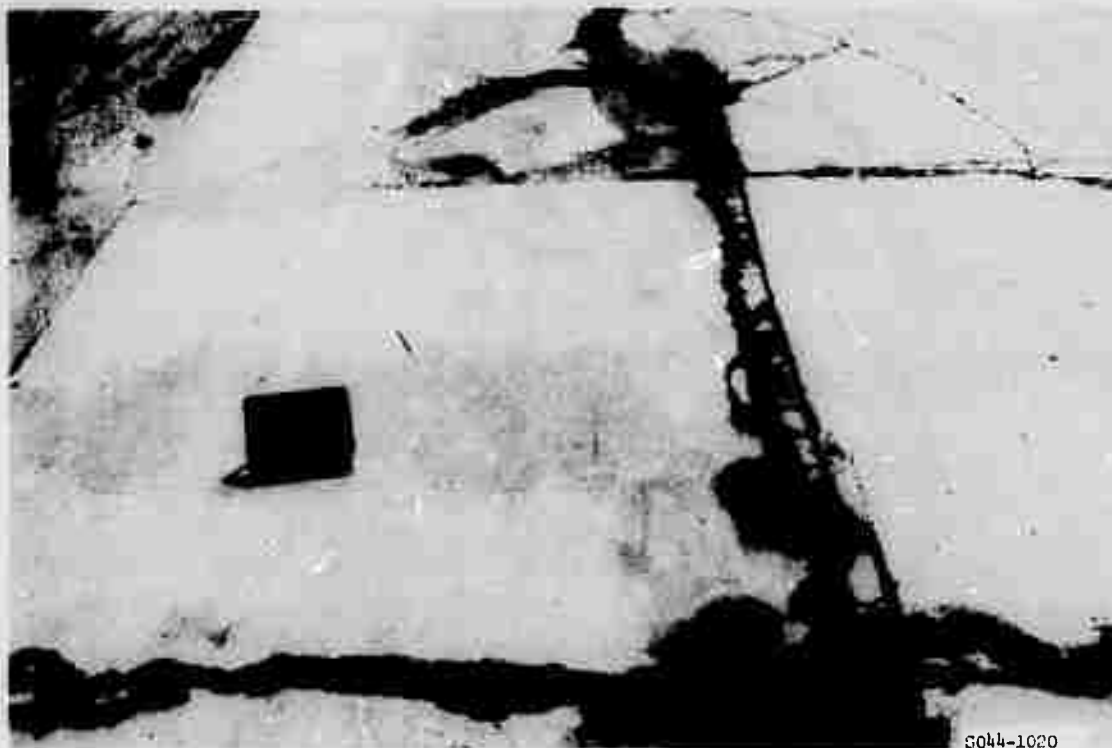
Figure A54. Subitem 5c, lane 2, rigid pavement test section, after 840 coverages by 240-kip twin-tandem assembly
